Safety Alert

RSA-2014-02

Thermal (or Metal) Spraying of Axles

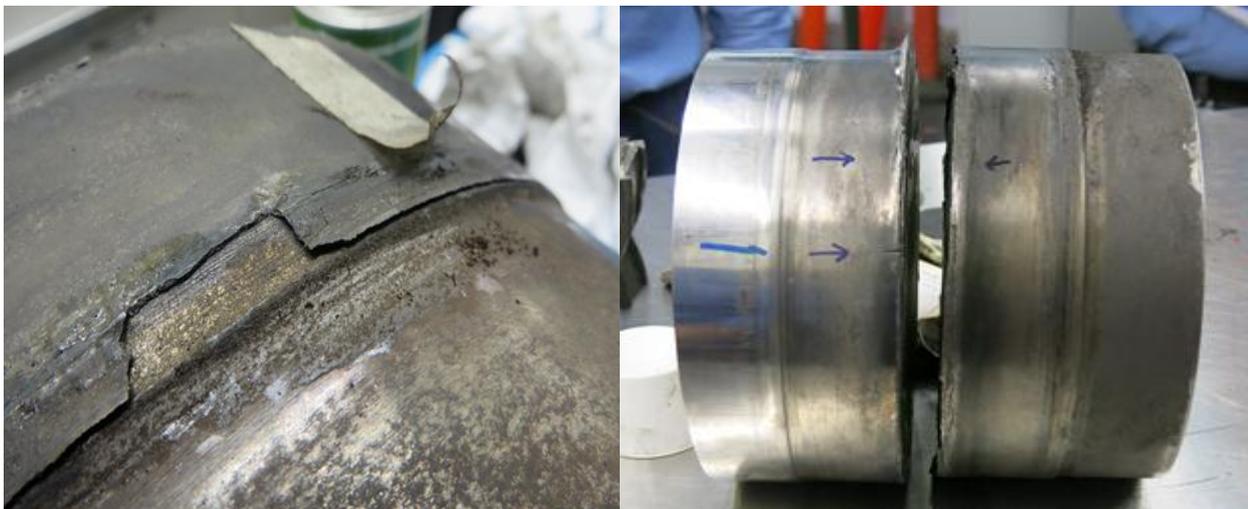
A major passenger operator recently suffered an axle failure on one of its electric multiple unit (EMU) fleet. Approximately fourteen (14) years prior, the axle in question had been subjected to thermal spraying on the gearbox bearing and oil thrower surfaces.

Indications that surface preparations used to promote proper bonding of the coating material resulted in minor circumferential grooving around the axle barrel which acted as origins for fatigue initiation. Although the rate of crack propagation was very low, the numerous fatigue initiators coupled with the fact that these were aligned (i.e. as in a continuous groove), eventually resulted in a fracture surface that was perpendicular to the longitudinal axis.

The above images depict the circumferential grooving and partial delamination of the metal coating and matched fracture surfaces

Rail Transport Operators may need to review and revise their current risk registers (and the associated standards and work procedures) in order to manage to a SFAIRP level, the hazards associated with an axle failure (other than at the journal bearing seat) due to thermal spraying.

In addition, due consideration needs to be given to the inherent limitations of non-destructive testing (NDT) and other inspection methods to detect the existence of any fatigue initiators on the metal sprayed axle surfaces during the scheduled inspection and maintenance interventions.
