Marine Safety Inquiry Report

Capsize and loss of kayaks off Anglesea
Tuesday 3 May 2016

Release date: 3 August 2016

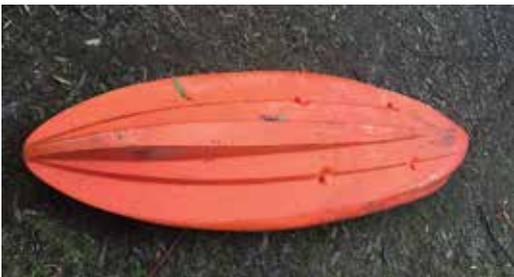
Figure 2 - Bottom of kayak, keel provides increased directional stability and helps reduce leeway (drift under the influence of wind)

- ii. an increased air draft and thus windage compared to traditional sea kayaks
 - iii. footholds which cater for a range of person sizes
 - iv. short waterline length which provides for a less efficient hull compared to longer vessels of similar displacement.

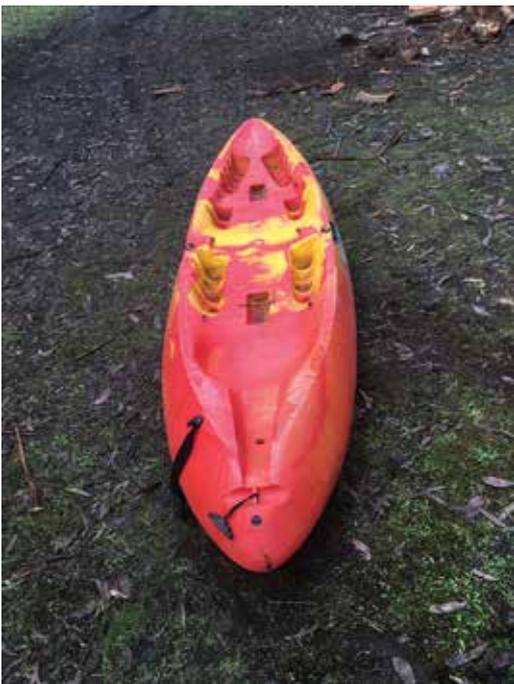
Figure 3 - Sit on top kayak supplied to Brauer College. Note capacity for two persons. Sit on top style of kayak is of a sealed hull configuration that provides integral buoyancy without the need for additional buoyancy.

- Supplied vessel characteristics – the kayaks used were two seat (double) sit on top kayaks with the hulls having a relatively high exposure to the wind. The relatively short waterline length makes these craft slower and requires more paddler effort compared to sea kayaks and surf skis.

47. Items supplied by the company were:
 - nine sit on top two person kayaks. This style of kayak provides:
 - i. a sealed hull that provides integral buoyancy

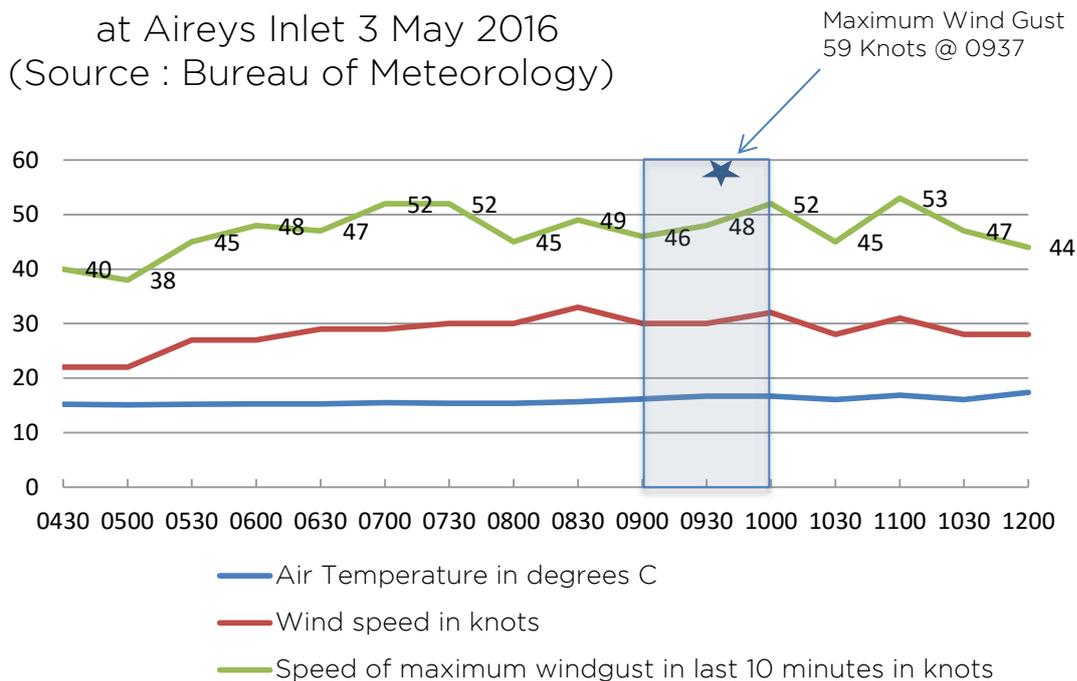
Figure 7 - Plot of weather observations, shaded area indicates the approximate timeframe of kayaking activity (0900-1000) The highest gust recorded by BOM was 59 knots at 0937hrs (BOM)

82. The weather observation data from Aireys Inlet shows that:

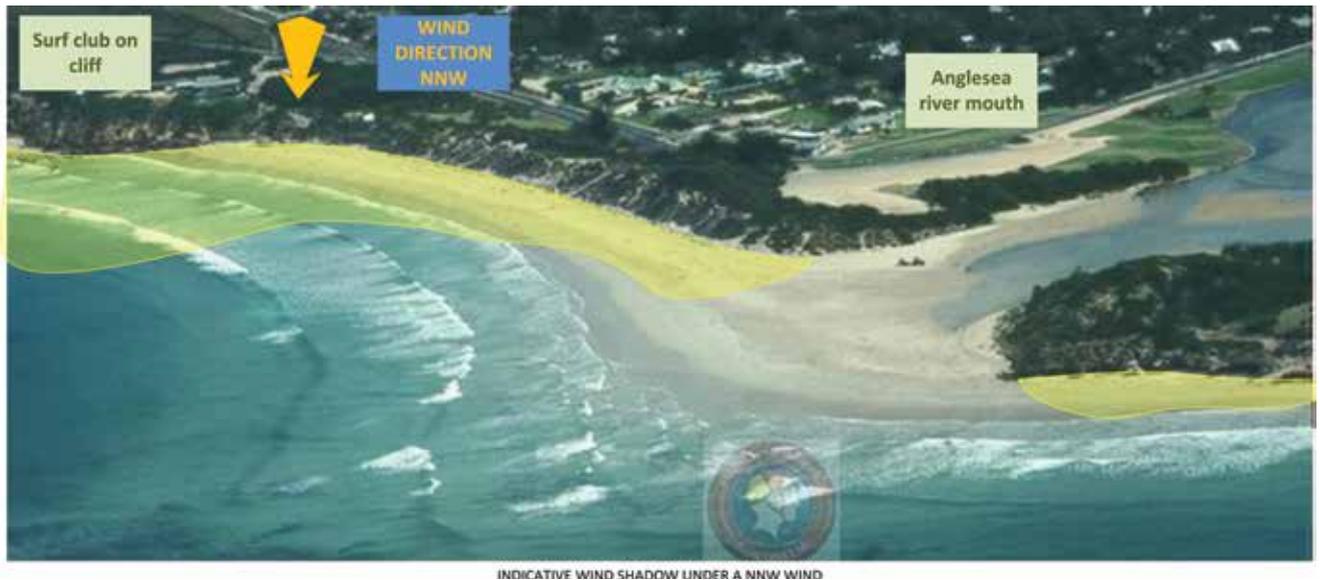
Figure 8 - Photograph of Anglesea beach indicating the effect of the cliffs and dunes in providing a 'wind shadow' when a NNW wind is blowing (SLSV)

88. It also indicates the lack of protection provided by the land at the mouth of the Anglesea River.

89. The sea kayaking activity was carried out close to the surf life saving club at the western end of the beach.

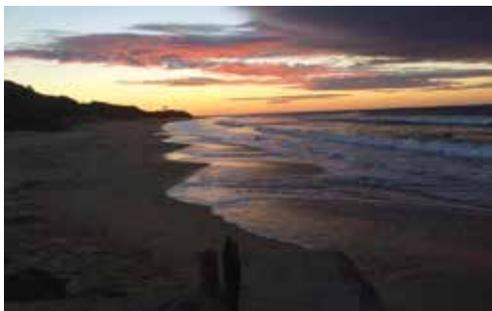
Figure 9 - Photograph taken by Brauer College student 3 May 2016 looking east (Brauer College)

90. The predominant wind was from the NNW which created an offshore wind.
91. When sighted from the shore the sea looked deceptively calm.
92. This is illustrated by the following image taken by a Brauer College student about 0615 on the 3 May 2016 at or close to the Anglesea Surf Life Saving Club.

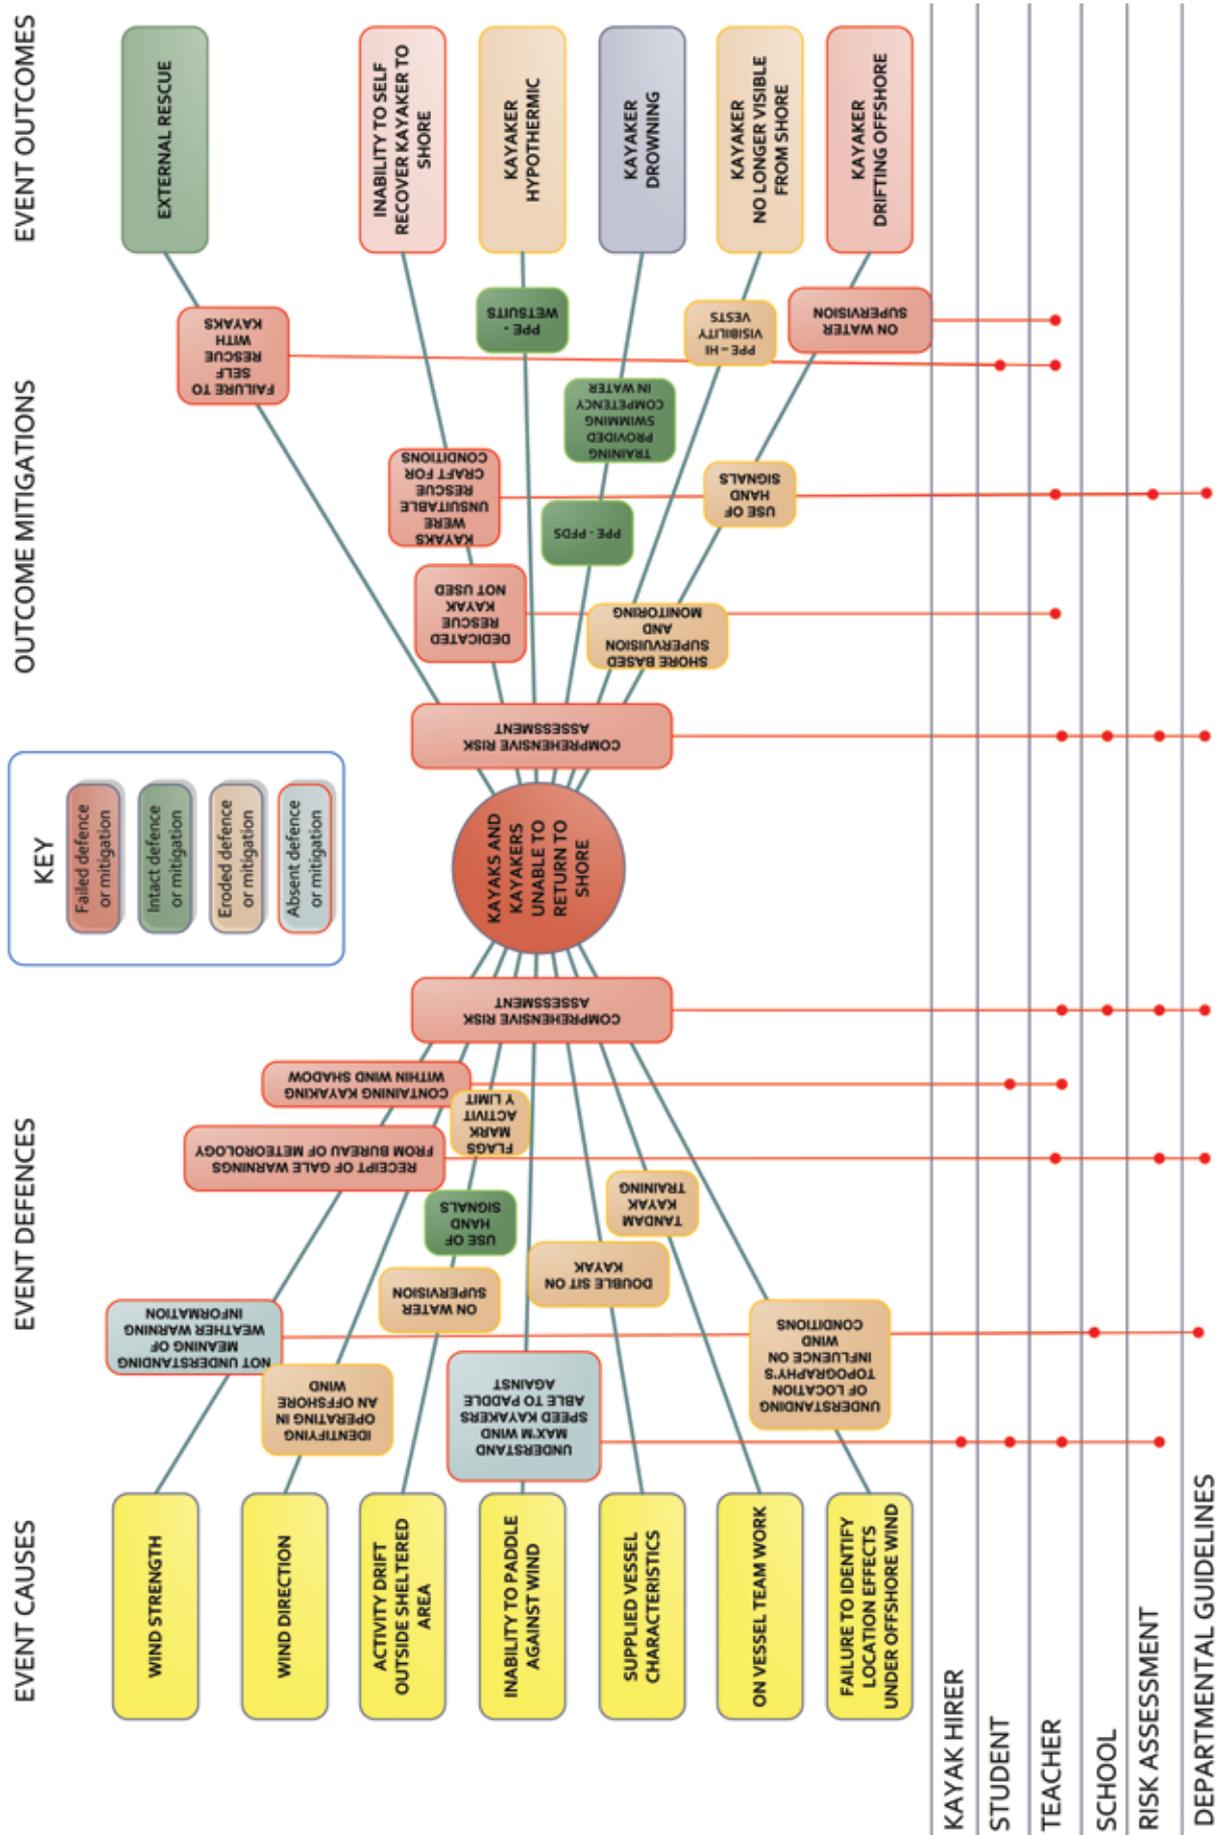
Figure 10 - Incident Bow-Tie illustrating potential causes of the incident, possible outcomes, event defences and outcome

97. This bow-tie model shows key aspects about the event with the causes on the left hand side and outcomes on the right. Various event defences and event mitigations either side of the centre point are the risk controls/defences to either prevent the event or to mitigate the outcomes.

98. Failed or absent defences identified are contributing factors to the outcome.
99. The outcome of the event was the need to be rescued by an external party.

100. A number of other potential outcomes were prevented by successful or partial mitigations.
101. The diagram illustrates the parties, processes or procedures where a failed defence or mitigation is located and/or who is responsible to manage the defence or mitigation. The effectiveness of a control is reduced if it is not fully implemented, maintained, observed or understood. These parties, processes or procedures are the:
